LIQUIDMETAL™
Industrial Solutions

Energy Center

Unit Z

**Primary Superheater Inlet Pendants
Inspection Report**

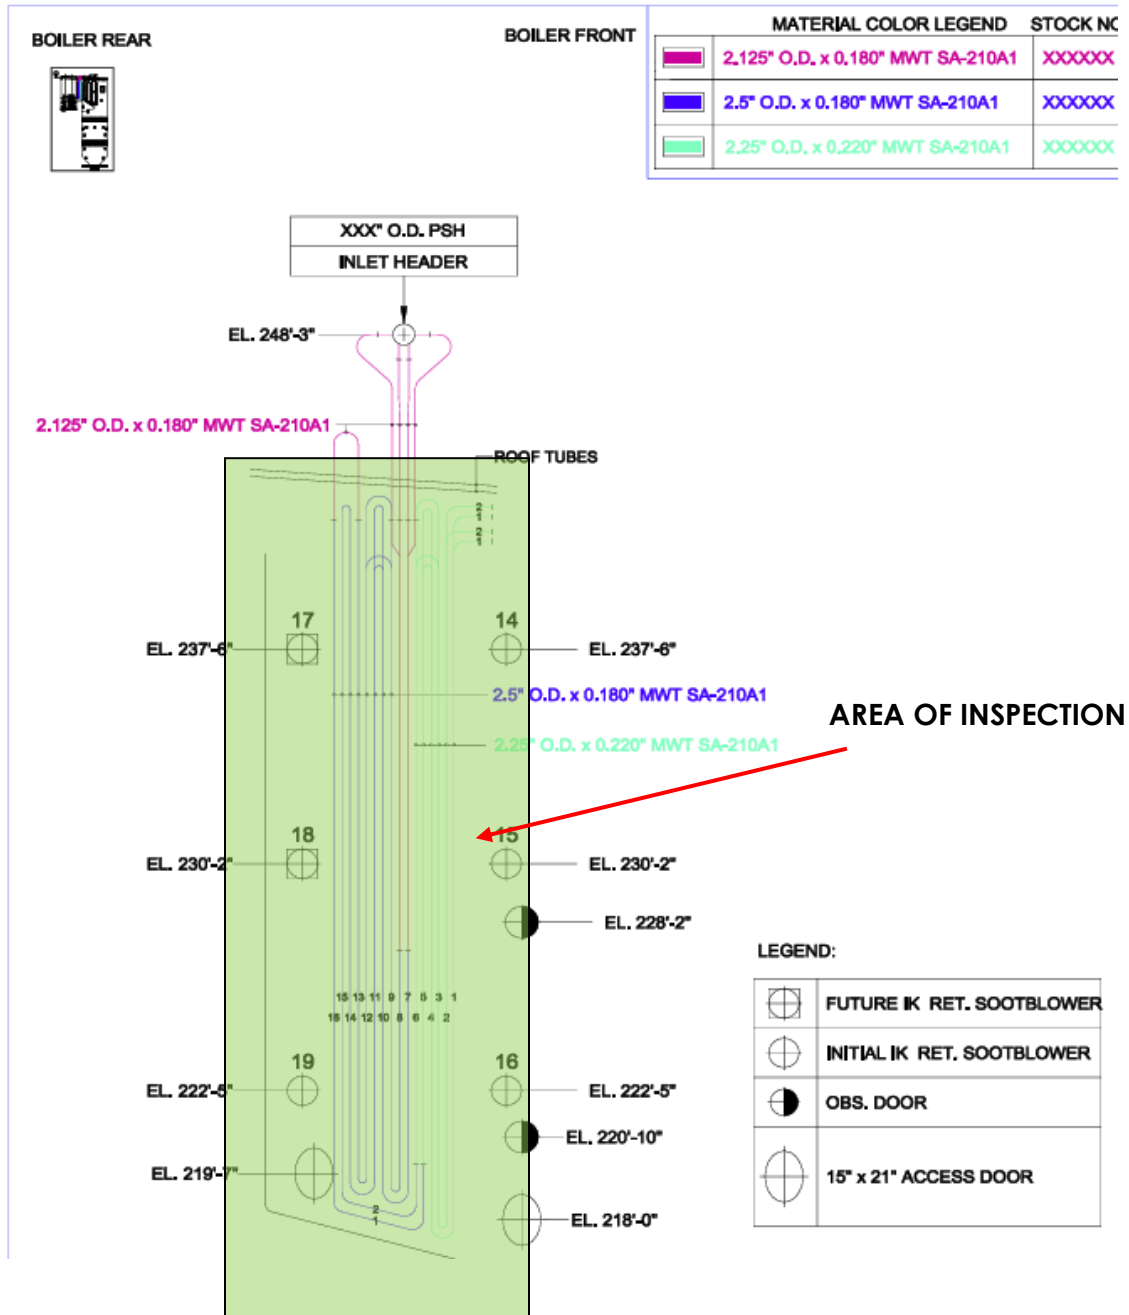
Item 1

There are (31) straight tubes experiencing moderate to severe sootblower erosion from SB-19 on the pendants listed below and 2 loops were severely eroded with UT's <60% remaining wall thickness.

Pendant	Tube	UT	Pendant	Tube	UT
2	4	0.124"	45	4	0.128"
7	6	0.123"	46	6	0.130"
10	5	0.127"	47	5	0.118"
11	6	0.125"	48	5	0.126"
11	7	0.130"	49	5	0.114"
13	4	0.124"	52	3	0.135"
18	4	0.128"	52	4	0.117"
19	7	0.128"	53	3	0.120"
23	4	0.135"	53	4	0.137"
24	5	0.130"	53	5	0.121"
25	4	0.108"	54	5	0.133"
25	4	0.140"	55	Loop #1-ISB	0.083"
27	4	0.130"	55	Loop #2-ISB	0.100"
27	5	0.134"	55	3	0.061"
31	5	0.130"	55	4	0.086"
32	5	0.087"	55	5	0.104"
32	6	0.125"	56	3	0.120"
38	5	0.077"	56	4	0.125"
39	4	0.124"	56	5	0.134"
40	6	0.128"	57	3	0.119"
42	4	0.131"	57	7	0.136"
43	5	0.131"

NOTE: Shields were previously installed on the last 3 tubes and some of the erosion on tube 3 was located directly under the shield.

Repair Recommendation: Once the alignment bar was removed and (32) areas of severe erosion was centered in the IK-19 lane. Install (30) 5' straight dutchman with location noted in table above.

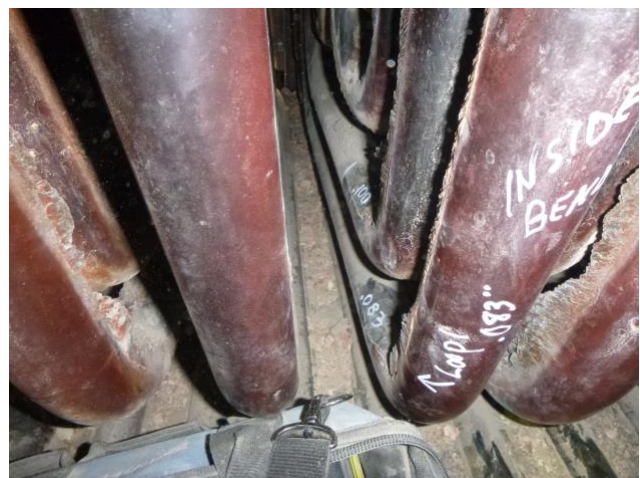
Item 2

There are (57) areas of moderate to severe sootblower erosion located on the underside of the rear alignment bar lugs were moderate on pendants 1-20 and severely eroded on pendant 21-57 (tube 16/last tube). This is due to the SB-19 lance channeling under alignment bar.

Note: The alignment bars were removed to gain access allowing additional inspections to be able to obtain a better depth of the SB erosion.

Repair Recommendation: Install (57) 2" x 2" padwelds on the rear of tube 16 (last tube) located underneath the alignment lugs due to IK -19.

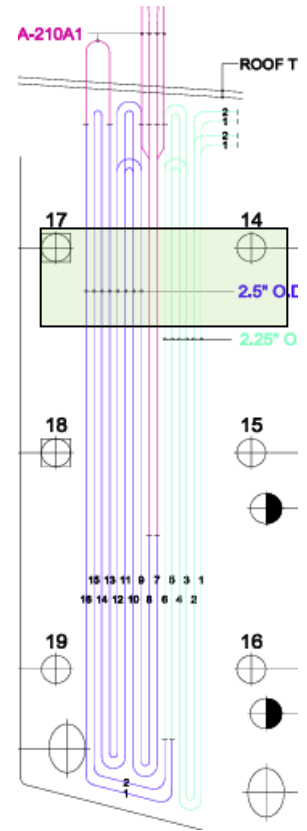
Item 3

There are (12) areas experiencing moderate to severe sootblower erosion from (SB-14) located on the front side of the primary superheater inlet pendants at the roof (Scaffold level 4/Top). The thickness readings ranged from 0.154” to 0.107” of the original 0.220” MWT.

Pendants	Tb	UT	Repair/Comments
Scaffold Level # 4 (top)			
48	5	Eroded Hole in Shield	Install 36” Shield
49	5	Eroded Hole in Shield	Install 36” Shield
50	4	Eroded Hole in Shield	Install 36” Shield
51	3	0.107”	Install 4’ dutchman
52	5	0.115”- 0.130”	Install 4’ dutchman
53	3	Eroded Hole in Shield	Install 36” Shield
53	4	0.115”- 0.130”	Install 4’ dutchman
56	3	Eroded Hole in Shield	Install 36” Shield
Scaffold Level # 2/3			
3	3	N/A	Install 4’ dutchman
3	7	N/A	Install 4’ dutchman
55	5	N/A	Install 4’ dutchman
55	6	N/A	Install 4’ dutchman

Tube Material: 2.25” O.D. x 0.220” MWT SA-210 A1

Repair Recommendation: Install (7) 4’ dutchmen on the pendants listed in the table above. Install (5) 36” straight shield on the rear of tubes (3, 4, or 5) due to IK -14.

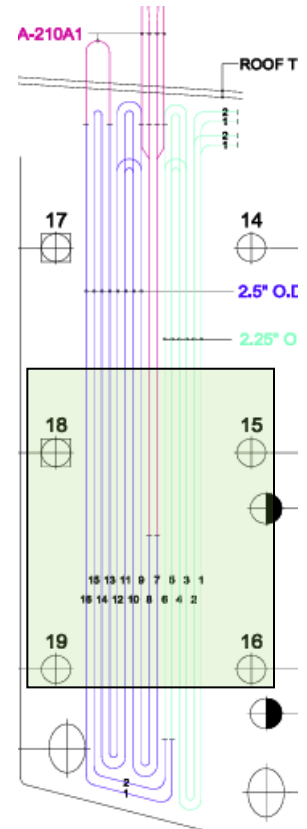
Item 4

There are (5) areas / tubes experiencing moderate to severe sootblower erosion from (SB-15 & SB-16) located on the front side of the primary superheater inlet pendants (Scaffold level 2/3). The thickness readings appear to be <70% with lowest UT reading of 0.140” of the original 0.220” MWT.

Pendants	Tb	UT	Repair/Comments
Scaffold Level # 2/3			
3-25	7	Moderate / Severe Erosion (0.140”)	Spread pendants to gain access.
49	3	0.164”	
51	3	N/A	
52	3-4	N/A	
53	3-5	N/A

Tube Material: 2.25” O.D. x 0.220” MWT SA-210 A1

Repair Recommendation: Once the racked pendants are let loose call for a re-inspected.
