LIQUIDMETAL™
Industrial Solutions

Energy Center

Unit Z

**Primary Superheater Inlet Pendants
Inspection Report**

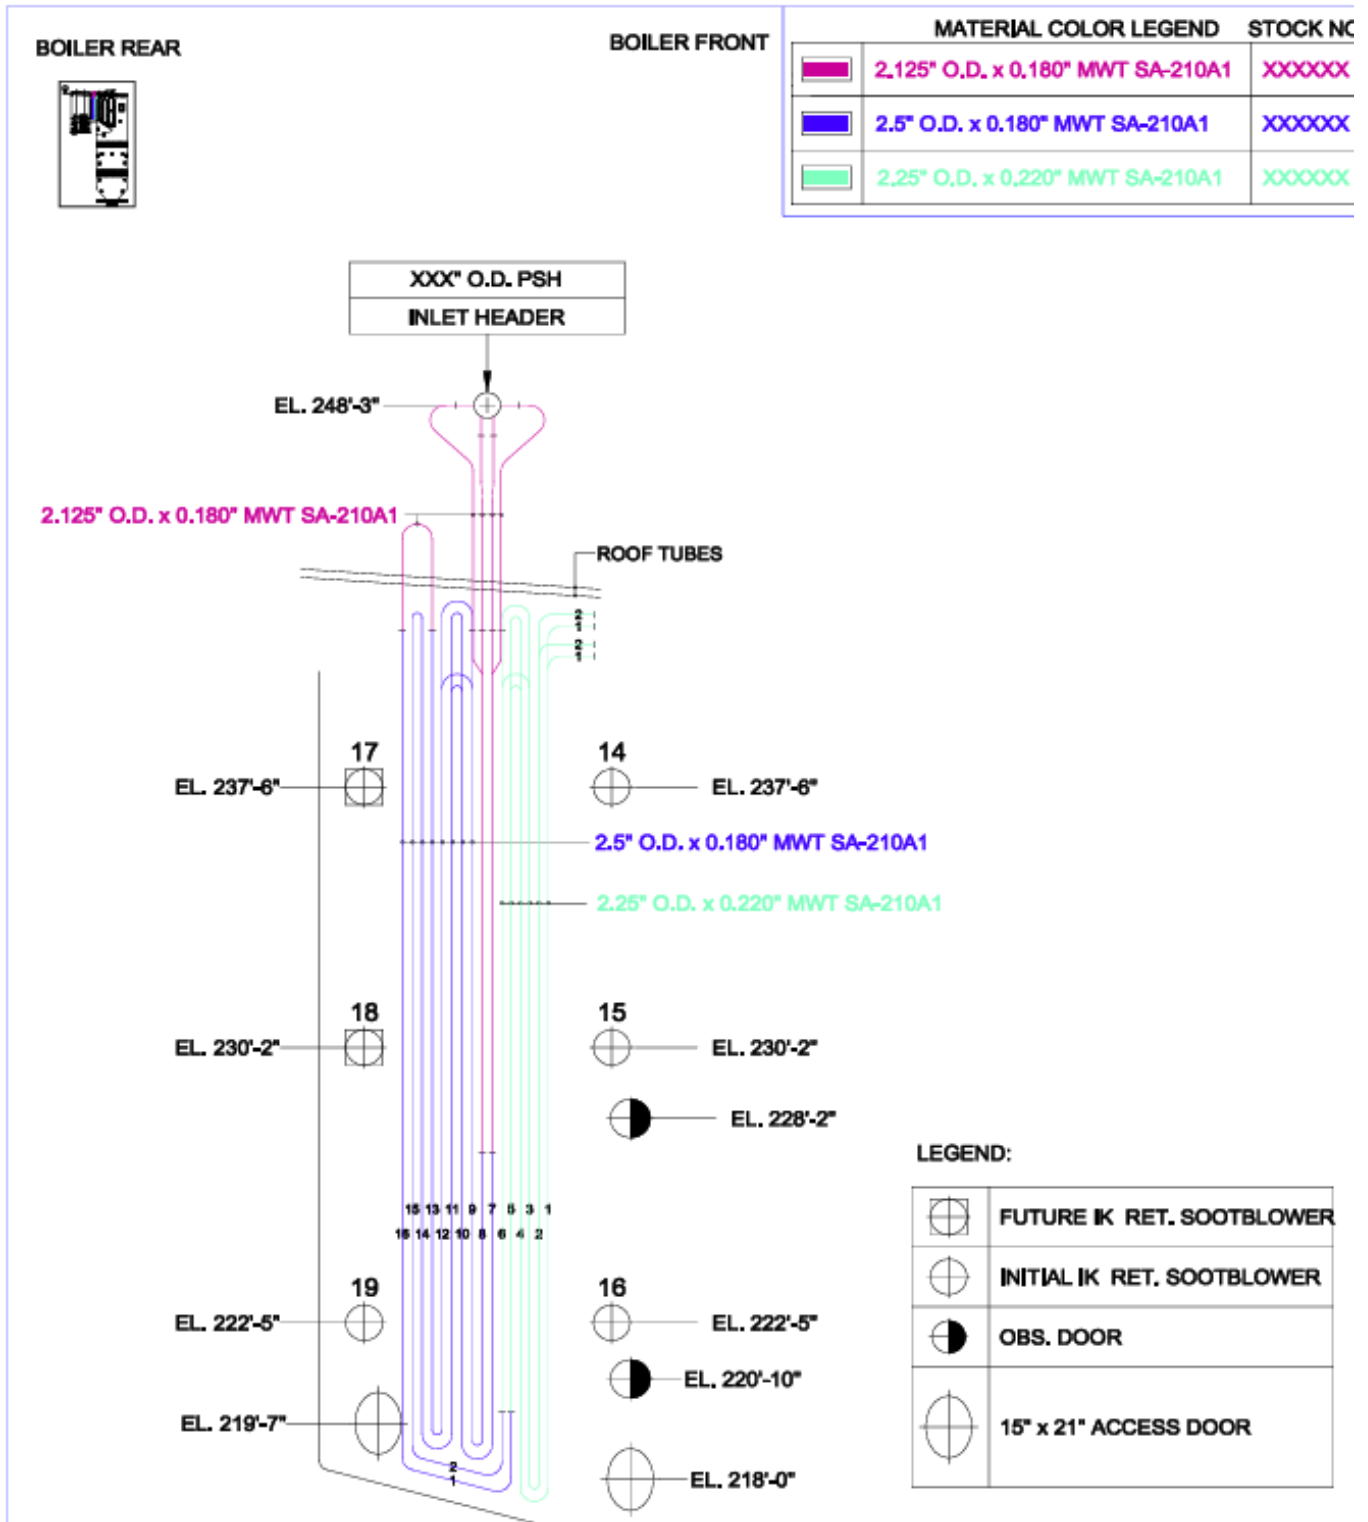
Pendants	Tb	UT	Repair/Comments
Scaffold Level # 2/3			
3-25	7	Moderate / Severe Erosion (0.140”)	Spread pendants to gain access.
49	3	0.164”	
51	3	N/A	
52	3-4	N/A	
53	3-5	N/A

Repair Recommendation: Once the racked pendants are let loose call for a re-inspected.
